Residential Inspection Report To NZS4306
for
Martin
Regarding Property Address:
70B Sample st Manurewa
Auckland
Prepared: July 04 2016

By: Right Home NZ Limited
Kathiravan Sivaprakasam BE
Auckland
099503858

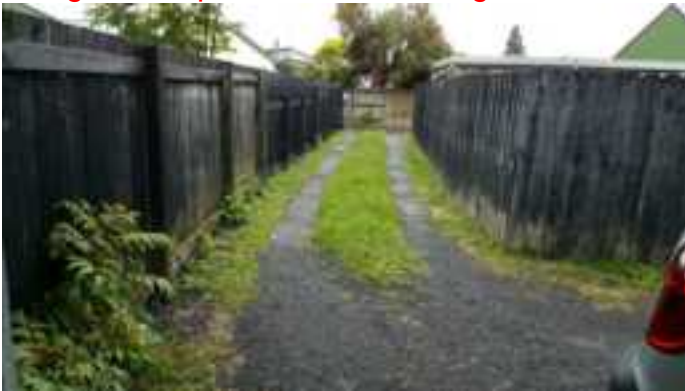
Condition

The grade slopes towards building / structure.

Improper sloping toward the building/structure can cause water damage and **structural damage**.

Recommend that this item be evaluated by a Licensed Building Practitioner (LBP) and corrected.

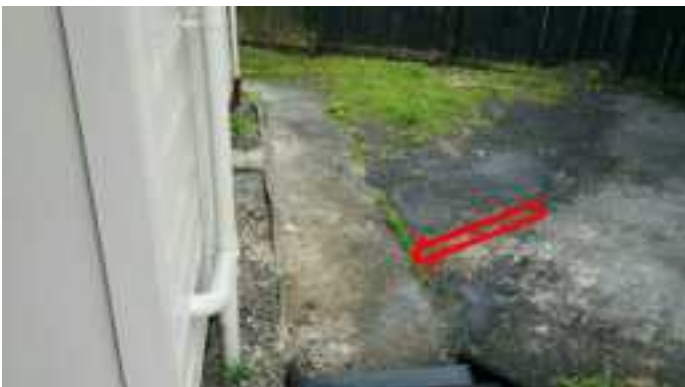
The grade slopes towards the building / structure.

Improper sloping toward the building/structure can cause water damage and structural damage.

The concrete walkway around the house is at lower level than the gravel driveway and it needs correction .

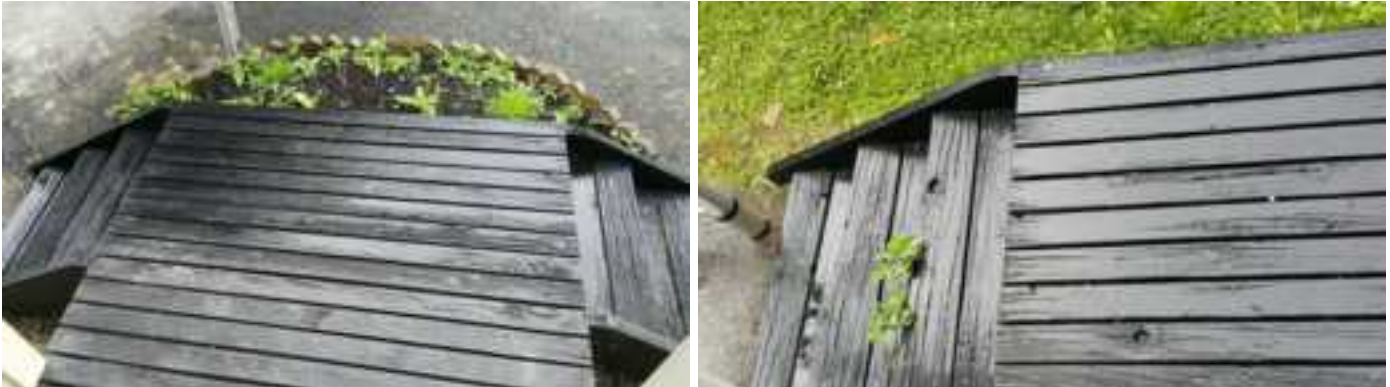
Deck height is too low, creating limited access/visibility to inspect under the deck.

The condition is marginal.

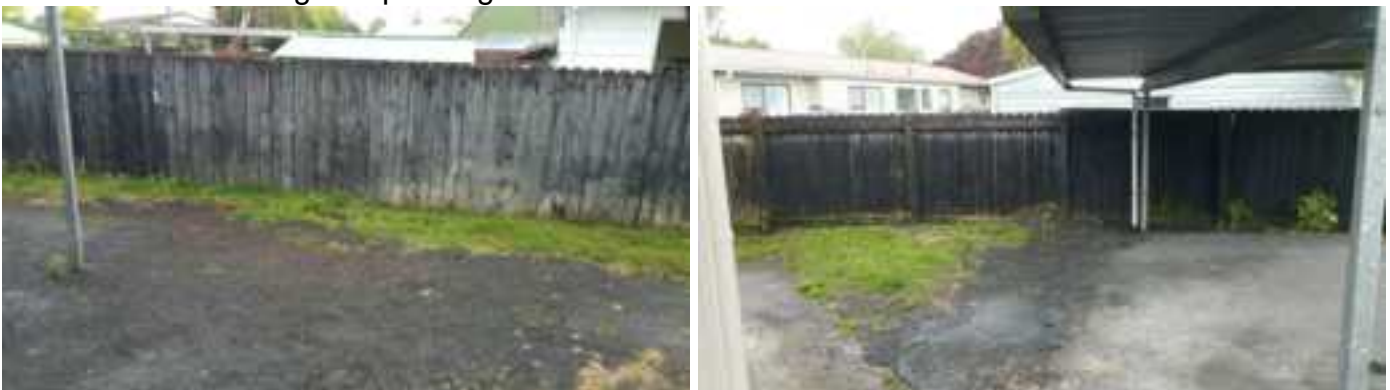
Noticed no defects.

Recommend cleaning and painting.

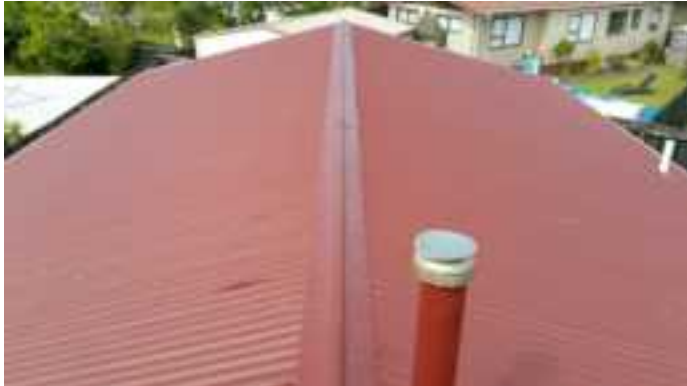
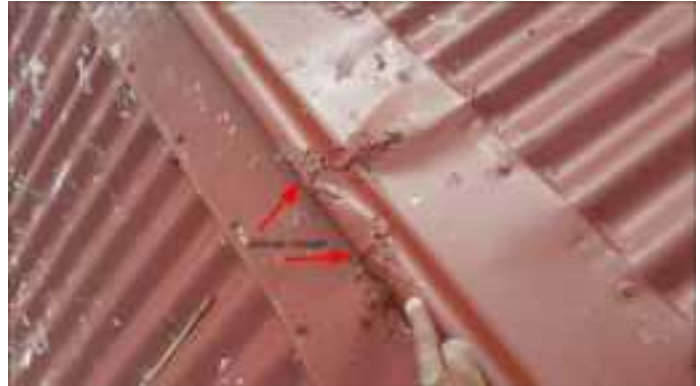
Appears to be repaired and newly painted. Noticed damages to lead flashing at ridge with attempted repairs with Silicon. But no evidence of any leaks when inspected from attic on this spot.

Recommend that this item be repaired or replaced in a professional way by a roofing specialist.

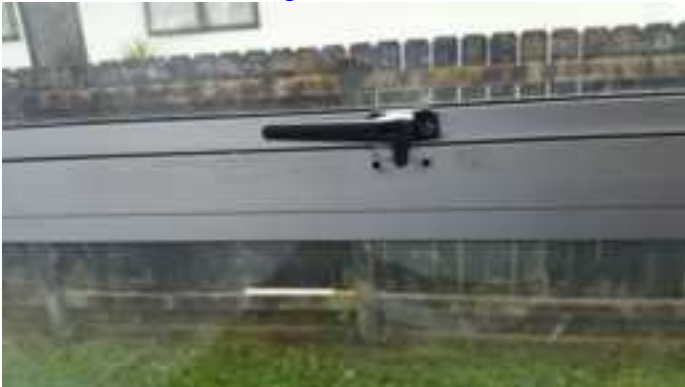
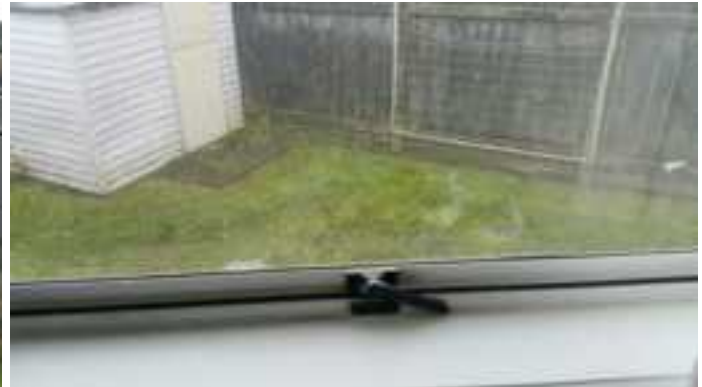
Window latch damaged.

Recommend that this item be repaired or replaced.

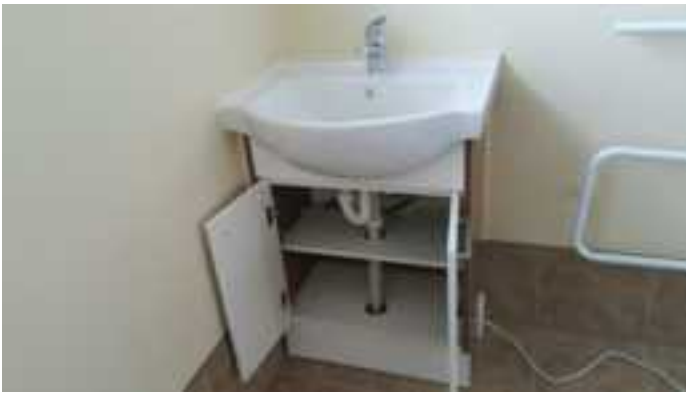
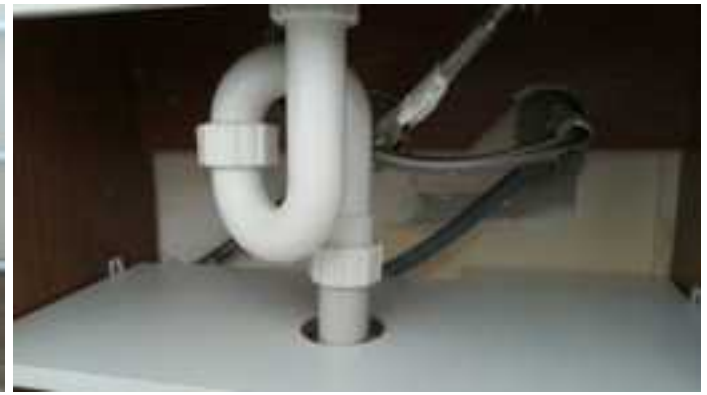
Sink plumbing with external piping which appears not of standard practice.

Recommend that this item be evaluated by a Registered Plumber.

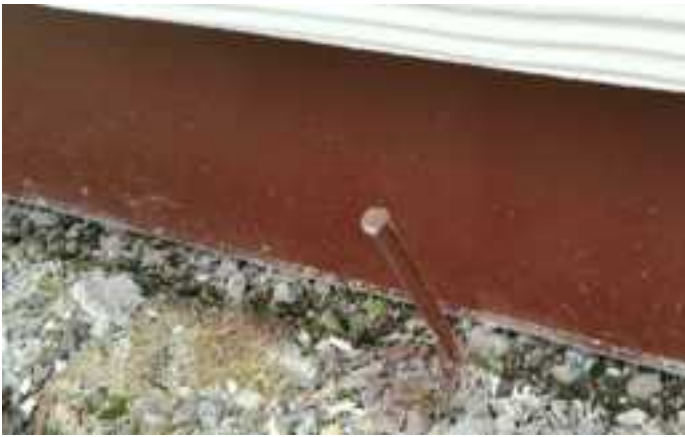
Noticed loose cables lying on the floor.

The ground earth clamp is not clamped to the earth rod, lying loose.

This is a potential Safety Hazard - risk of electrocution.

Recommend that this item be repaired by a Registered Electrician.
