Residential Inspection Report To NZS4306
for
Martin
Regarding Property Address:
70B Sample st Manurewa
Auckland
Prepared: July 04 2016

By: Right Home NZ Limited
Kathiravan Sivaprakasam BE
Auckland
099503858

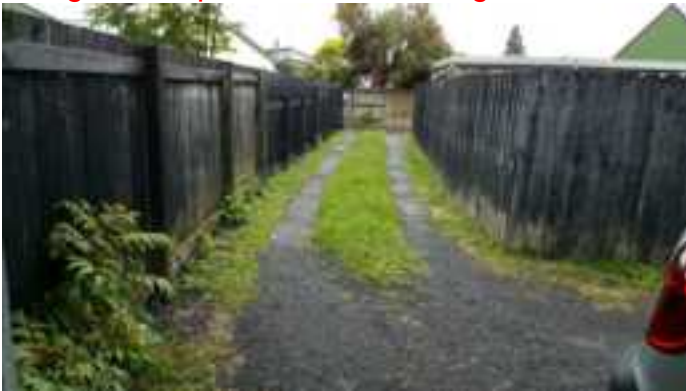
The grade slopes towards building / structure.

Condition

Implication

Improper sloping toward the building/structure can cause water damage and **structural damage.**

Recommend that this item be evaluated by a Licensed Building Practitioner (LBP) and corrected.

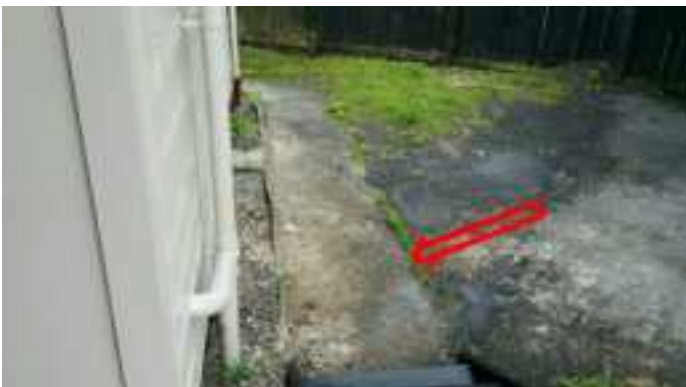
The concrete walkway around the house is at lower level than the gravel driveway and it needs correction .

The grade slopes towards the building / structure.

Improper sloping toward the building/structure can cause water damage and structural damage.

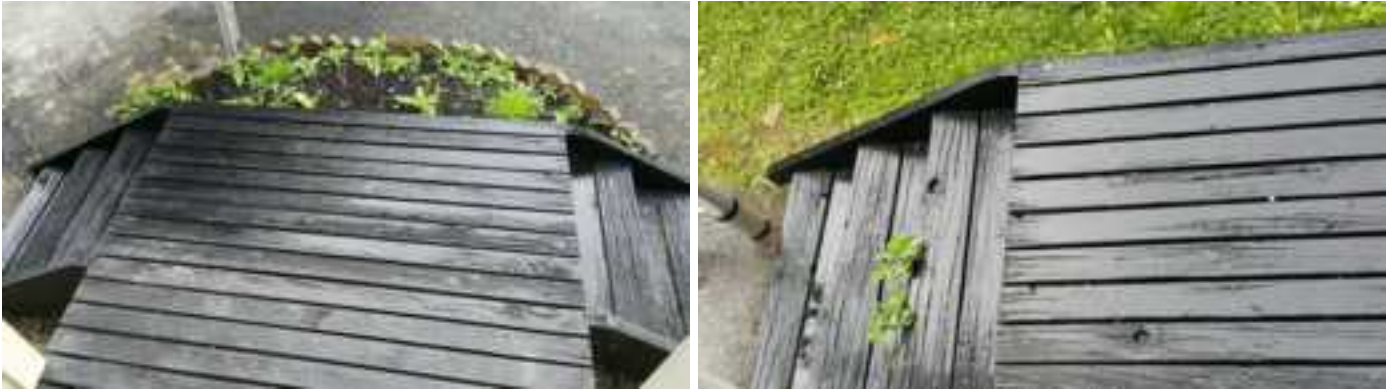
Deck height is too low, creating limited access/visibility to inspect under the deck.

The condition is marginal.

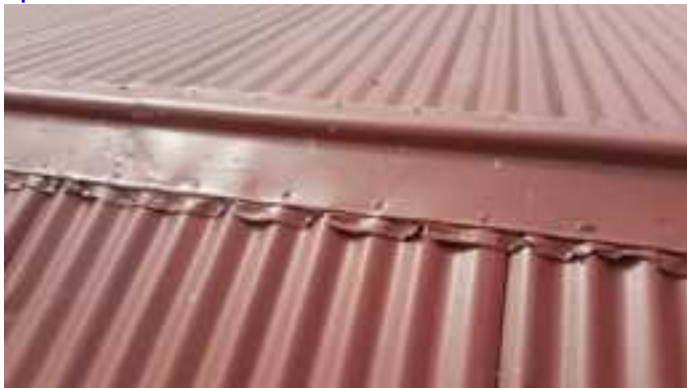
Appears to be repaired and newly painted. Noticed damages to lead flashing at ridge with attempted repairs with Silicon. But no evidence of any leaks when inspected from attic on this spot.

Recommend that this item be repaired or replaced in a professional way by a roofing specialist.

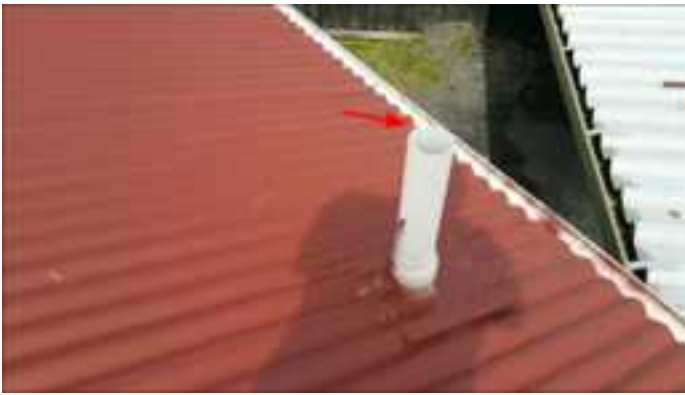
Toilet vent without capping.

Recommend a capping be installed.

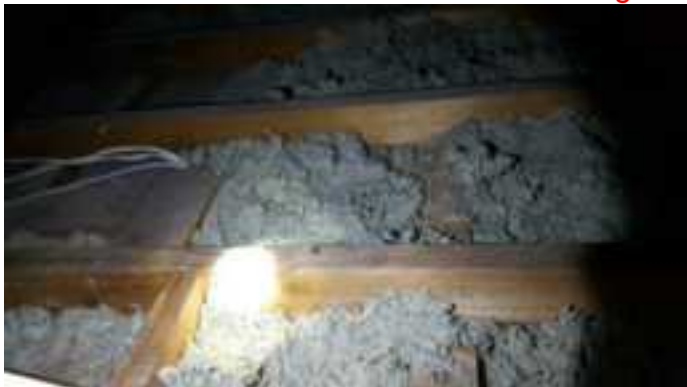
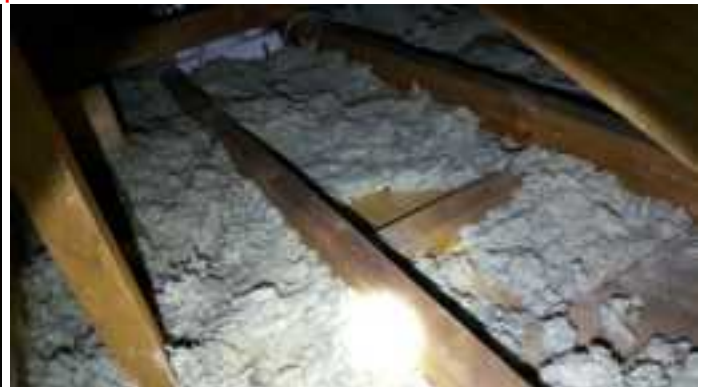
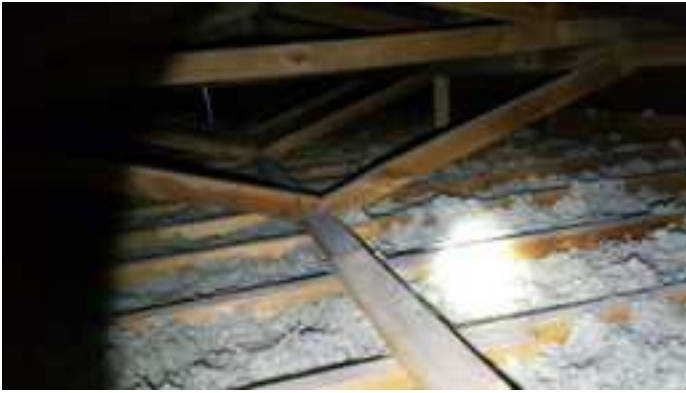
Uneven distributon noticed and of not enough depth.

Recommend that this item be repaired or replaced with a new insulation by a Insulation specialist.

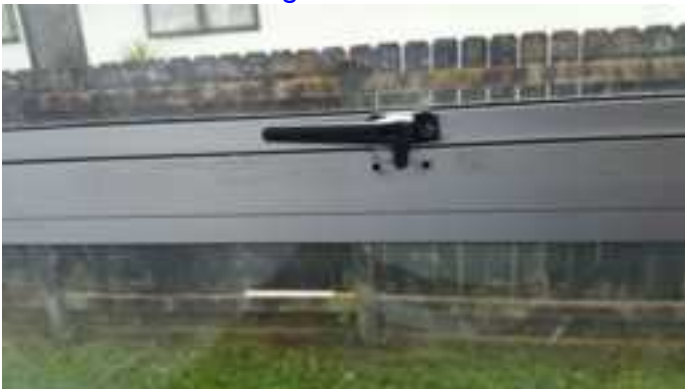
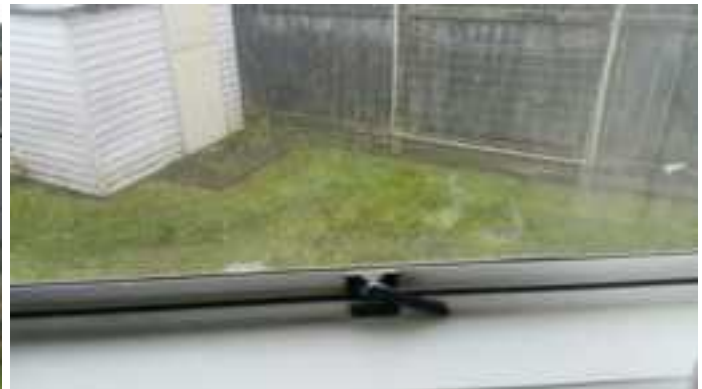
Window latch damaged.

Recommend that this item be repaired or replaced.

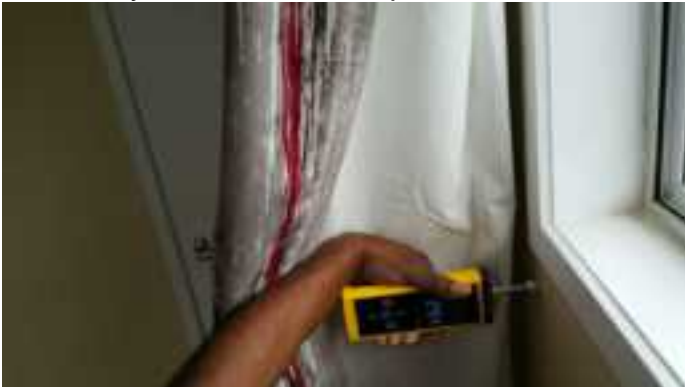
Evidence of rot repair on the bottom corners of the windows.

Found dry at the time of inspection when checked with moisture meter.

The aluminium joinery is of old type as with the age of the house, without condensation channels. Needs extra care to keep condensation off the windows with sufficient ventilation.

Recommend that this item be monitored on an on-going basis.

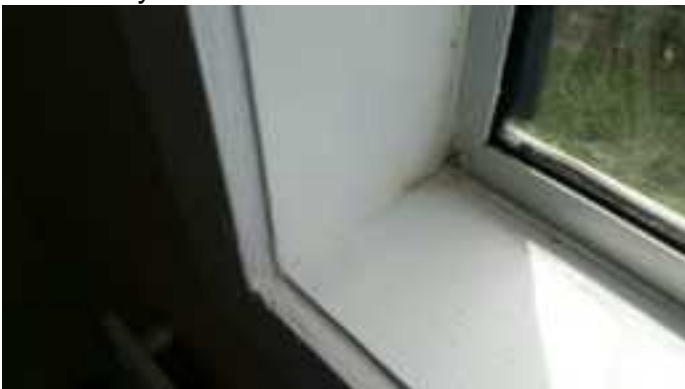
Noticed evidence of rot repair. Poor finish noted.

Tested dry with moisture meter on the wall surface, but any internal damage is unknown.

Tested dry.

Recommend that this item be evaluated / repaired by a LBP.

Recommend that this item be monitored on an on-going basis.

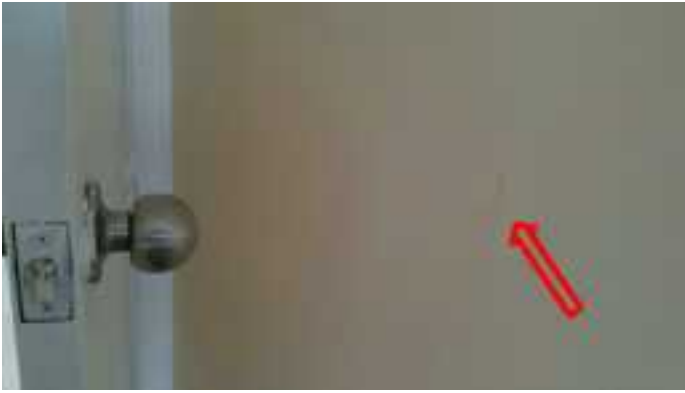
Noticed wall damage by lock.

Recommend that this item be repaired and a door stop installed.

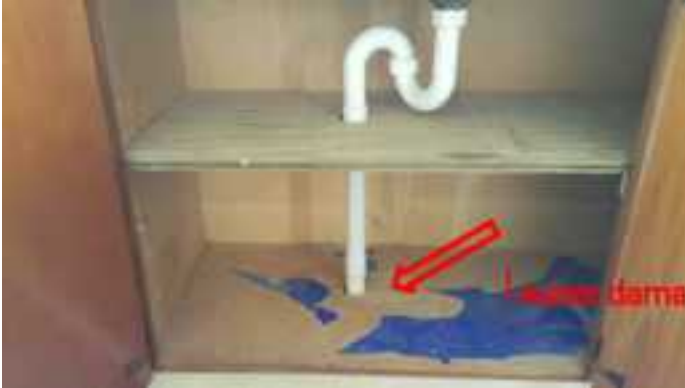
Noticed signs of repair. Signs of previous water damage under the sink. No current leaks can be found. But any hidden damage is unknown.

Recommend this be monitored.

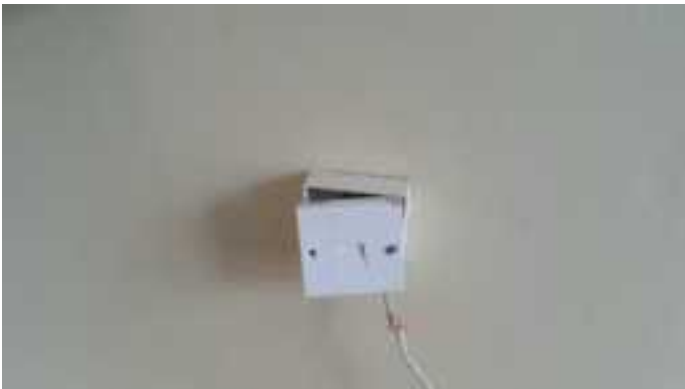
Screws missing in telephone jack point cover and the wiring condition is unknown.

Recommend that this item be repaired or replaced by a Registered Electrician.

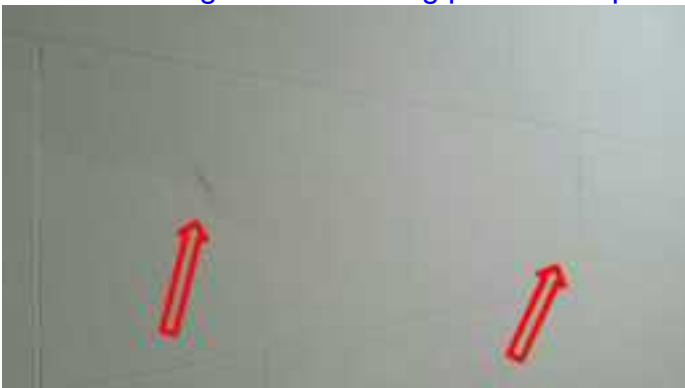
Noticed damages to the ceiling panels in 2 places.

Recommend that this item be repaired or replaced by a LBP.

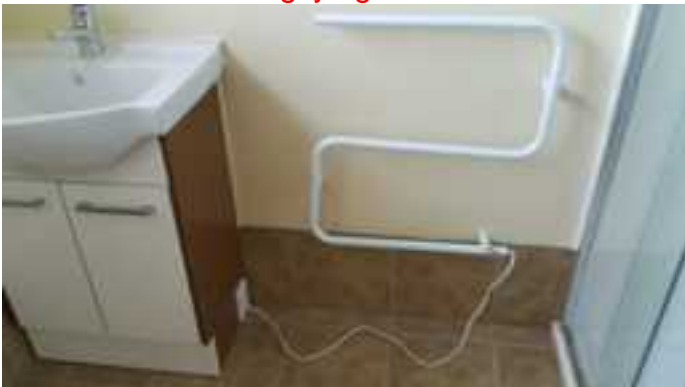
Towel heater cabling lying loose on floor.

This is a potential Safety Hazard.

Recommend that this item be repaired by a Registered Electrician.

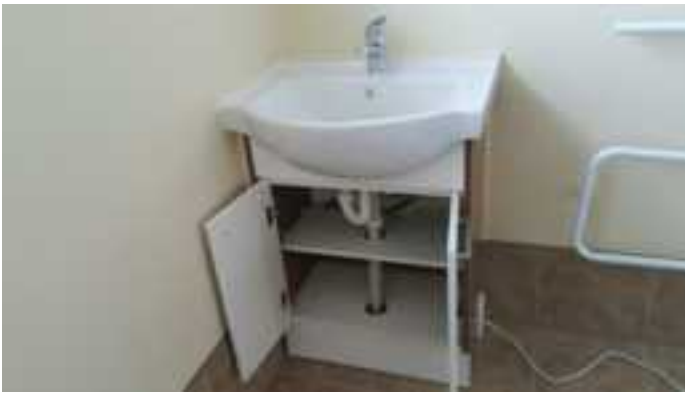
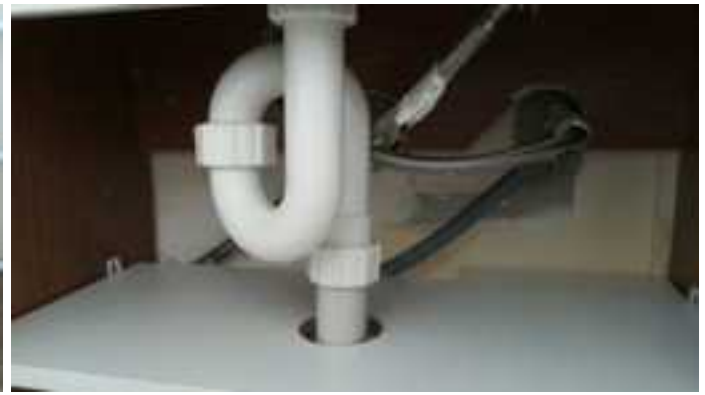
Sink plumbing done with external piping which appears not of standard practice.

Sink plumbing with external piping which appears not of standard practice.

Recommend that this item be evaluated by a Registered Plumber.

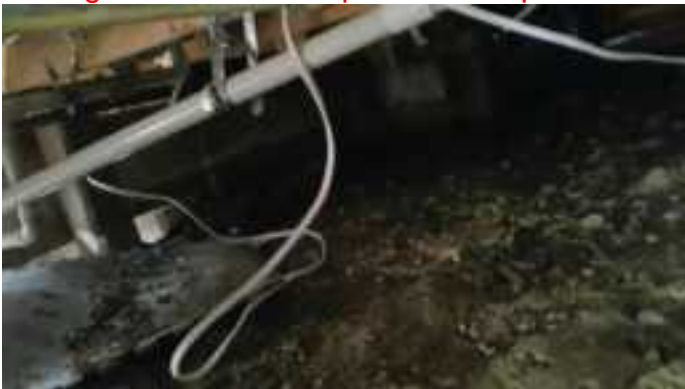
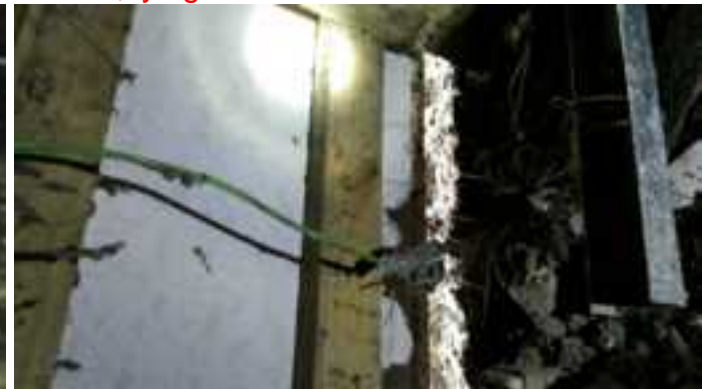
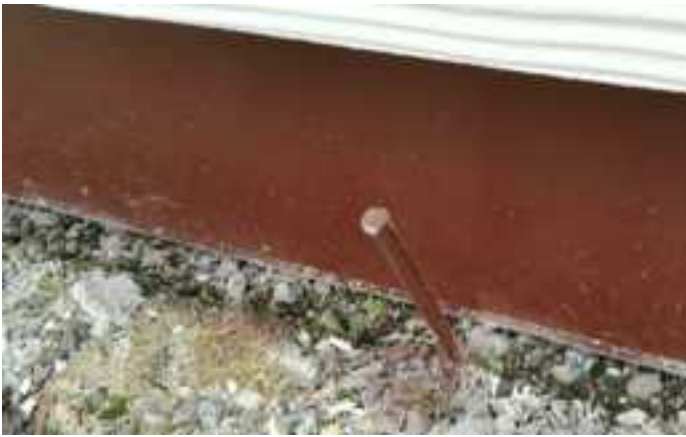
Noticed loose cables lying on the floor.

The ground earth clamp is not clamped to the earth rod, lying loose.

This is a potential Safety Hazard - risk of electrocution.

Recommend that this item be repaired by a Registered Electrician.

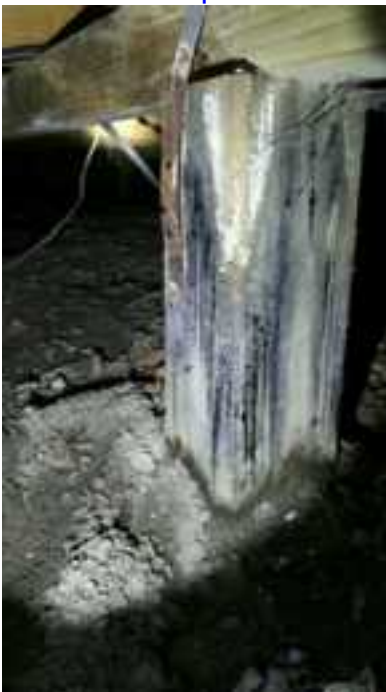
There is evidence of water staining on the posts and the Post to Bearer braces are rusted and broken in few places.

Recommend that this item be repaired or replaced by a LBP and a ground vapour barrier be installed.
