Residential Inspection Report To NZS4306
for
Martin
Regarding Property Address:
70B Sample st Manurewa
Auckland
Prepared: July 04 2016

By: Right Home NZ Limited
Kathiravan Sivaprakasam BE
Auckland
099503858

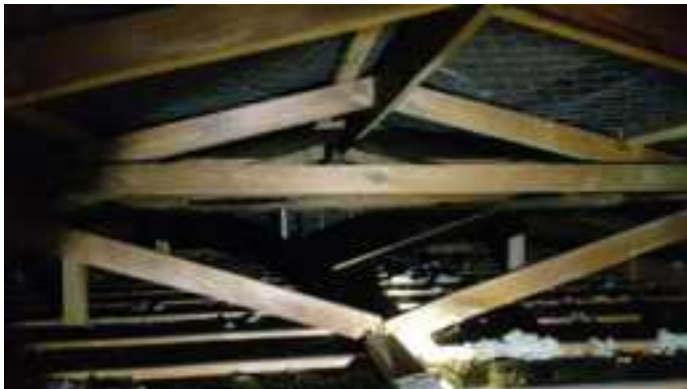
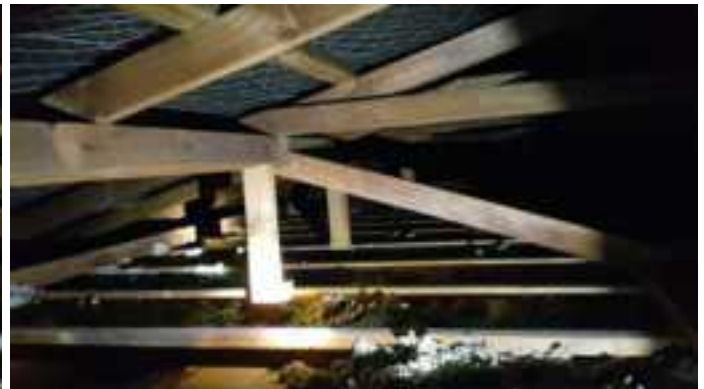
9.3: Insulation

Uneven distributon noticed and of not enough depth.

Recommend that this item be repaired or replaced with a new insulation by a Insulation specialist.

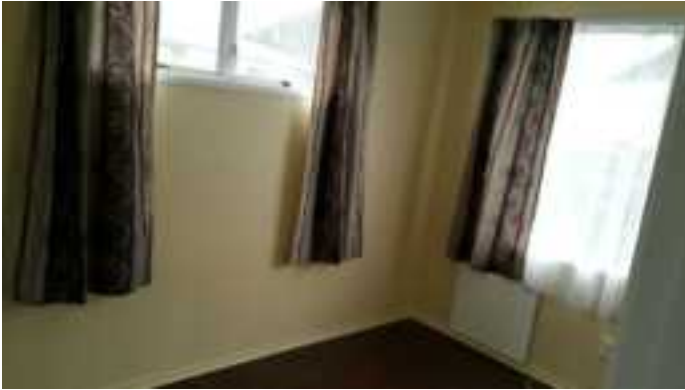
11.2: Windows and Screens

Evidence of rot repair on the bottom corners of the windows.

Found dry at the time of inspection when checked with moisture meter.

Recommend that this item be monitored on an on-going basis.
